Manhole Inspection Summary

Manhole # S33UU1006MH

Location Address: **220 GOODALE RD**

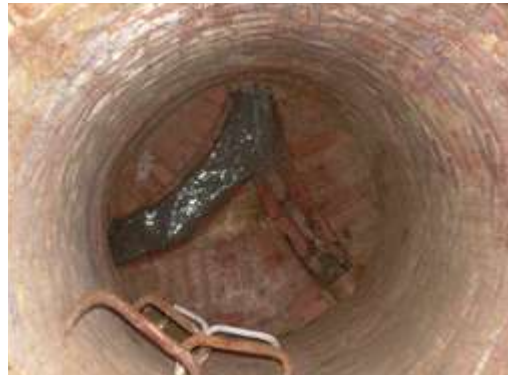
Top View

Corroded steps.

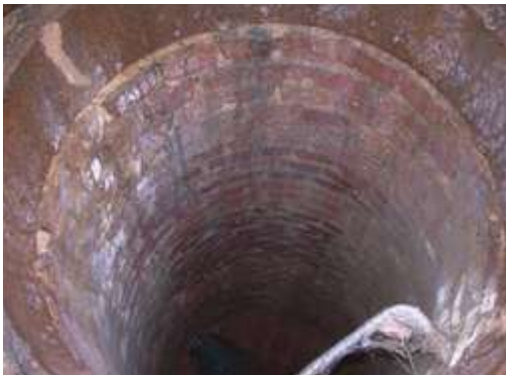
Defect

Frame leaks. Adjustment deterioration and infiltration - other side.

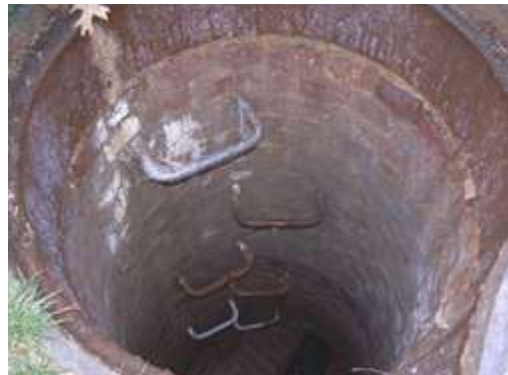
Defect

Adjustment deterioration and infiltration.

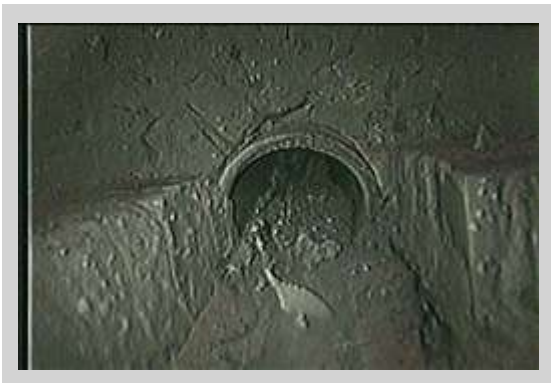
6 in. Circular Gravity Sewer Pipe In @ 4 O'Clock

Channel deterioration.

Deposits: ☐ None ☒ **Mud** ☐ Sludge ☒ **Debris** ☐ Grease

Silt Depth: **2** (in.) Deposits Extent: **Light**

Infiltration: **Evidence** Pipe Seal Cond: **Cracked**

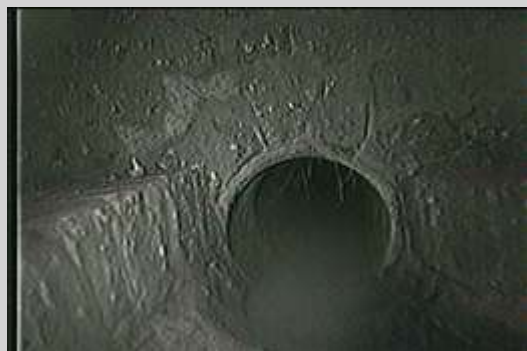
Pipe In @ 8 O'Clock

Infiltration: **Evidence**

Pipe Seal Cond: **Roots**
